## Check your brakes! By Frank Sibly

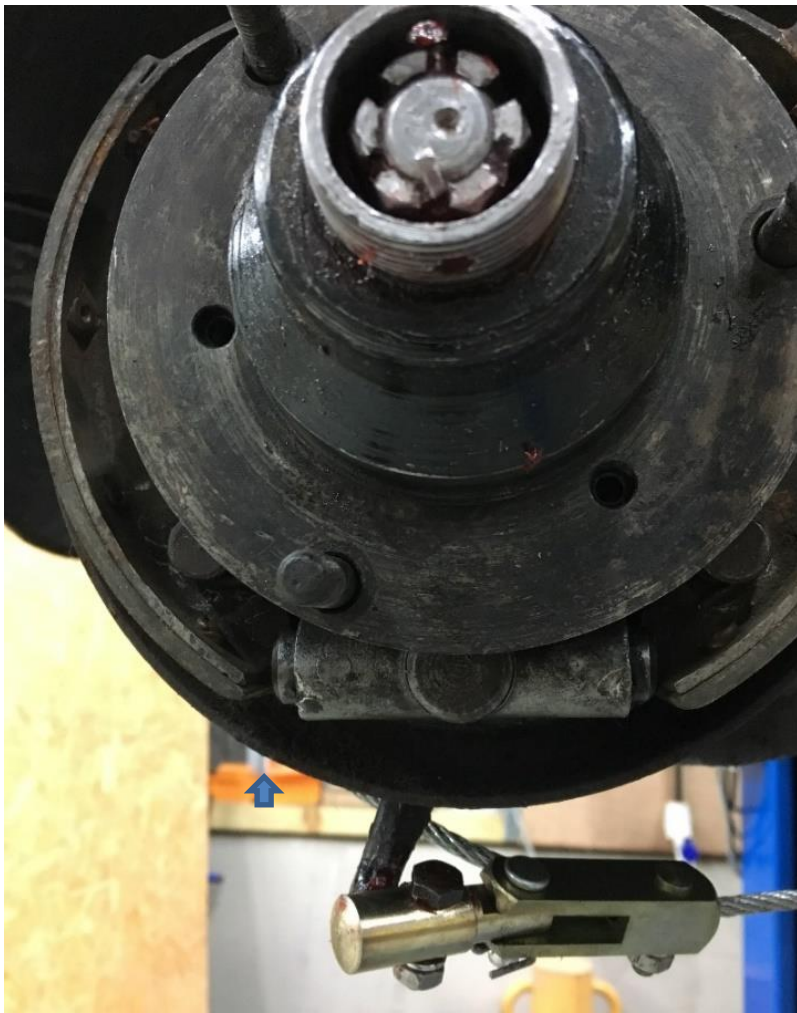
*Following rebuild, brake cable (nearside) now pointing forwards (away from brake cable)*

After we swopped the cams over, the brakes are so powerful that the wheels lock up under full braking. A word of warning, changing the cams over took about 30 hours.

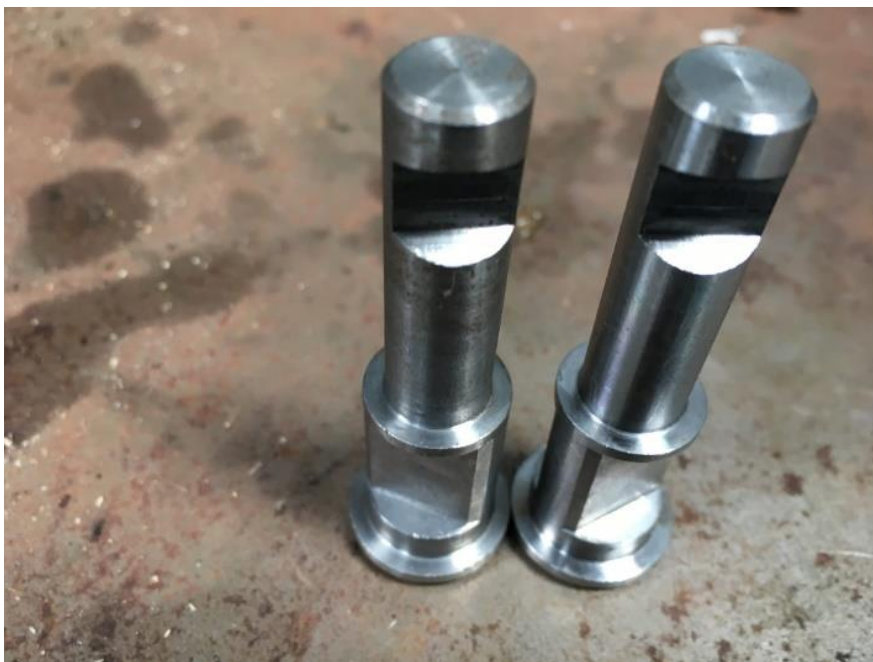
It was surmised that the brake cams had been inadvertently swapped over in a previous rebuild, or that the wrong cams had been used. An example of a pair of cams is given below, but apparently many different angles of cam were used on the various models.

*Note different alignment of the cams for each side. The upper indentations are for the cotter pin which attaches them to the brake lever, and the lower ones are the cams that push the pistons that in turn push on the brake shoes.*

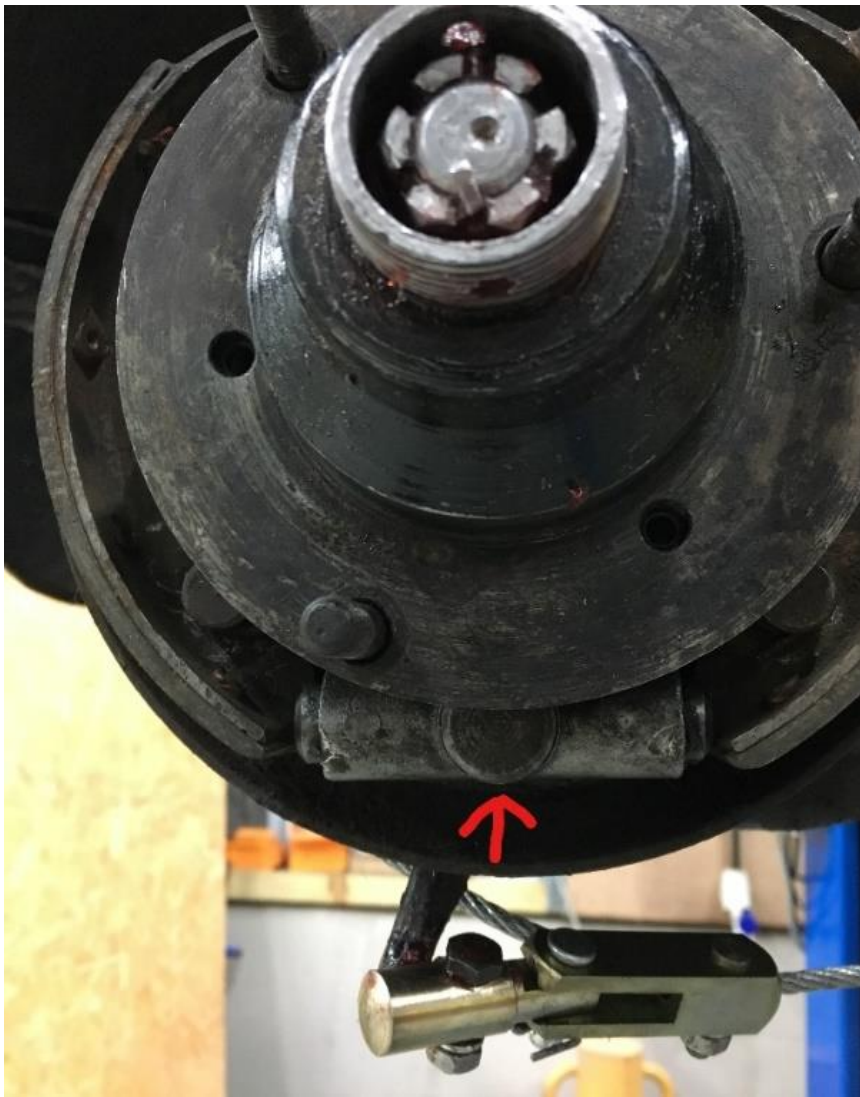
*Cam (red arrow) cannot be removed without removing hub first. Photo after rebuild, showing front nearside hub, with lever now resting in forward facing position.*

When we reattaching the brake lever with a cotter pin, we found that increased angulation of the lever could be achieved, depending on which way the cotter pin went through the lever.
