Front Hub Removal

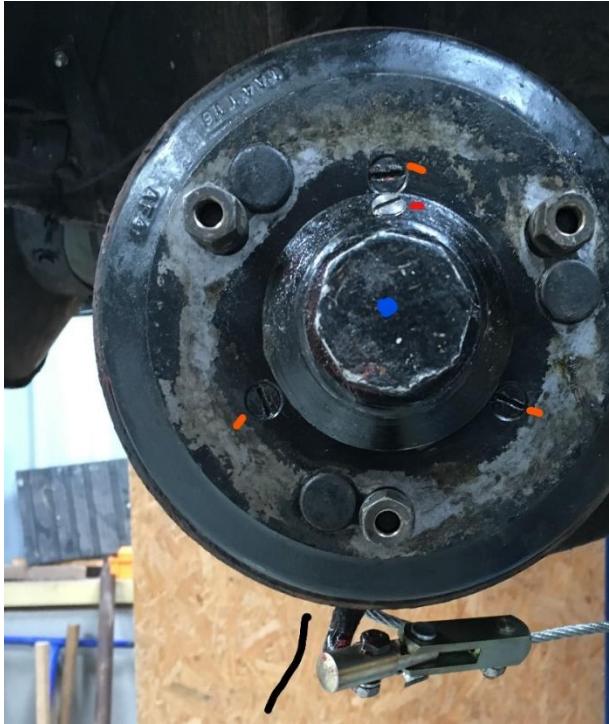
Front brake drum: Orange dots adjacent to the 3 screws that hold drum onto hub. Blue dot is on grease cap, which is not tightly attached. Red dot is blanking screw for hole that allows high melting point grease into hub. Black line shows the brake lever, after rebuild, now angled away from brake cable when at rest.

To re-position the brake levers (see previous Crankhandle) necessitated removal of the hubs as to gain access to the brake cams that needed to be changed. Removal of wheels and brake drums is straightforward, the drums being held on by 3 screws (orange dot), which are not particularly tight.

First remove the hub grease blanking screw (red dot in photo above). If you replace the bearings with “sealed for life” type, then this screw will not be needed in reassembly.

Next remove the grease cap (blue dot in first photo) with a 7/8" Whitworth spanner.

On reassembly, we packed the hubs with high melting point (red) grease, forcing it through the hole in the outer hubs, (red dot in 1st photo) and also packed the grease caps (blue dot in 1st photo) on the front hubs.

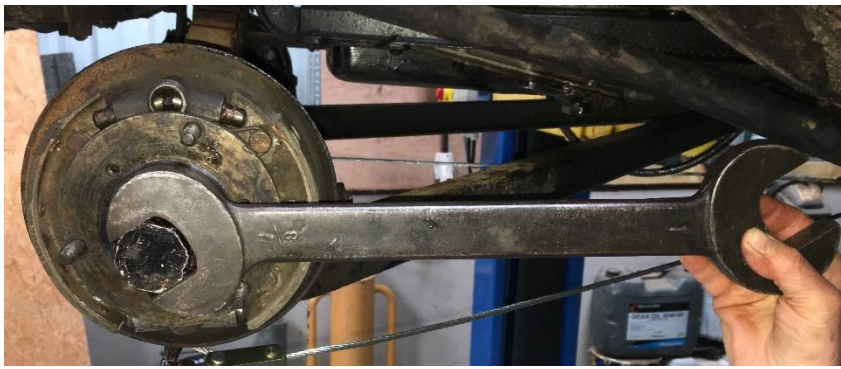
*7/8" and 1" open jaw
Whitworth spanner, worth
about £20 on eBay*

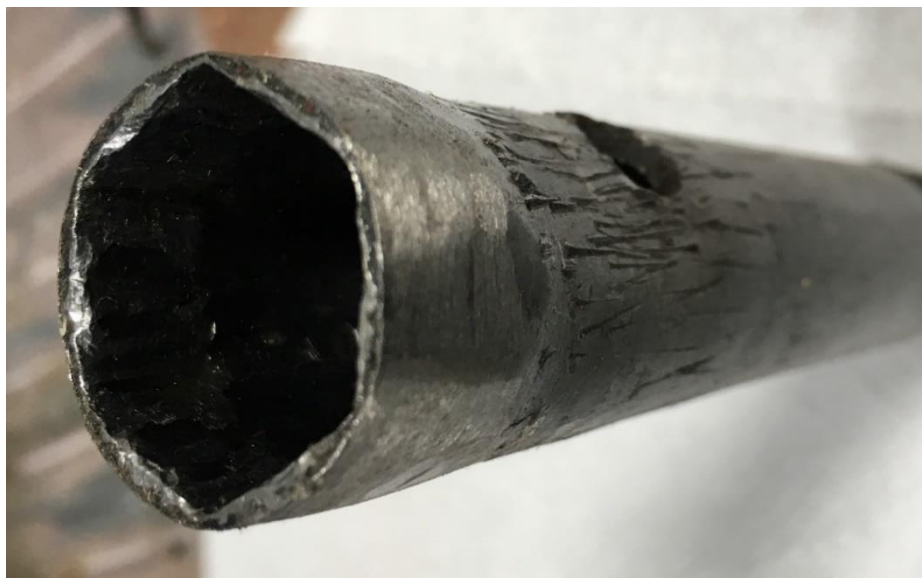
*Box spanner for cutting the
split pin in the front stub
axle*

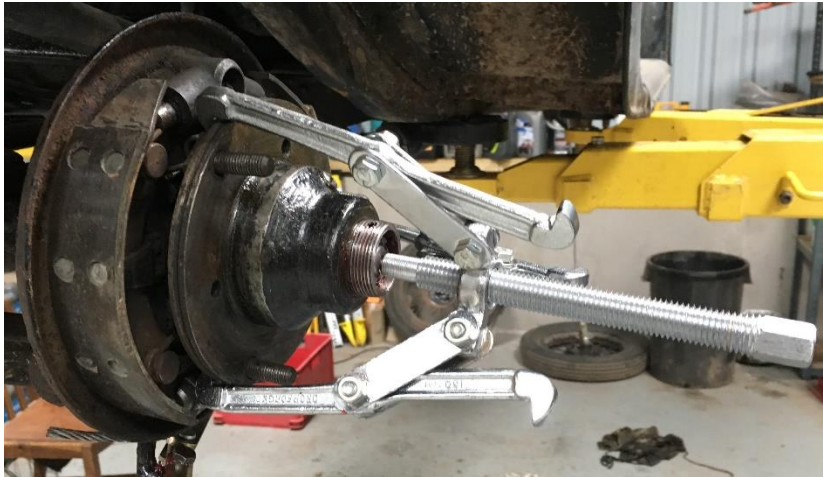
Once the axle nut was removed, the front hubs could be removed in one piece, using a tripod hub-puller, which we used, rather than the Austin puller, because the hub thread was damaged. I tried the same on the rear hub, but it won't work, as the inner part of the rear hub is fixed to the axle casing.
