Hereford Austin 7 Club Newsletter Club Information

***Club Meets Last Tuesday of the month (note new venue)
At The Buckingham 141 Whitecross Road Hereford HR4 0LS
7.45pm for 8.00pm Start
Newsletter Issue 6 – January 2011***

Notes on the Restoration an 1930 Austin Seven Mulliner Sports

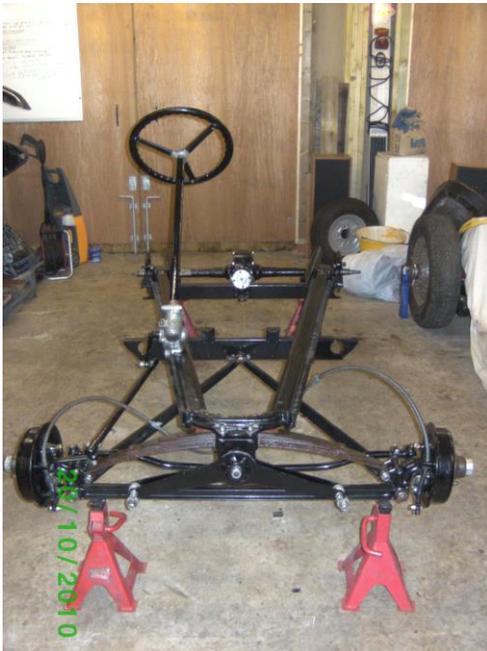
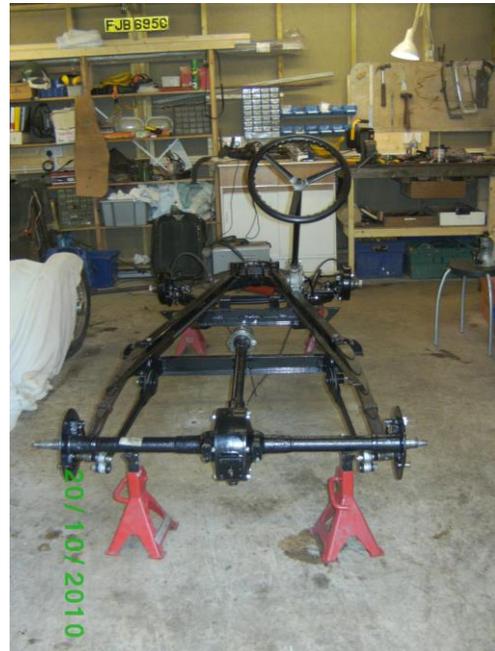
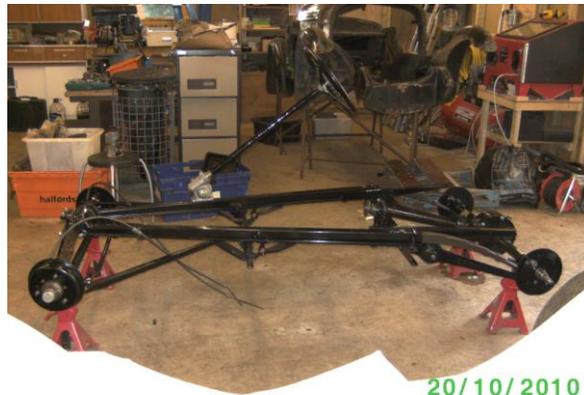
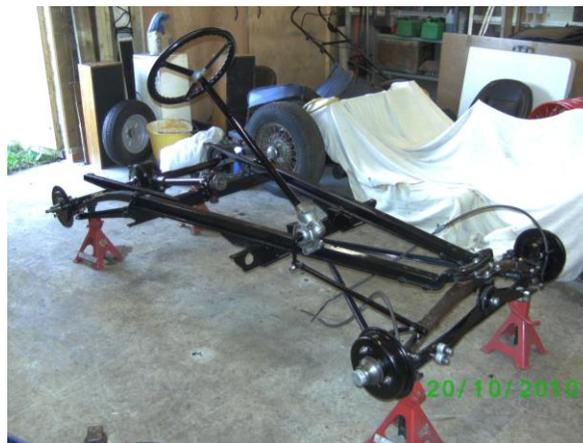
Progress on the restoration of the Mulliner has been steady rather than dramatic. I have concentrated on the chassis and that is nearing completion. The chassis, front and rear axles and the radius arms have been powder coated, the remaining bits have just been carefully painted. I have replaced and reamed out all the bushes in the front suspension and the braking system. In addition I have renewed the brake cams and replaced the steel end caps to the aluminium brake shoes. I have read that you should drill the centre of the cap and the end of the brake shoe and fix the end cap to the shoe with a countersunk screw. I don't think that this is necessary as the cap should be a tight fit onto the end of the shoe and it is retained in position laterally by the flanges each side of the brake cam. Time will tell if I am right or wrong. The front linings are not too badly worn and I decided not to replace them, it was however necessary to take up the wear. There is no provision for adjustment in early Sevens so I adjusted the brakes by wrapping small pieces of curved shim around the brake shoe pivot until the shoes were just touching the drums. It was very time consuming but worked out all right in the end. I used new linings on the rear brakes and did not find it was necessary to use any shims.

I have also tackled the steering. I renewed the kingpins and bushes, all the other bushes and connections in the steering set up and finally repaired the steering box. When everything was assembled the result was very tight steering; the biggest single contributors to the tightness were the kingpins. The problem was that in order to eliminate vertical play it is necessary to insert shim washers on the kingpin above the axle eye and it is difficult to get the correct thickness washers. In the end I compromised by accepting more play than I originally wanted in exchange for getting an acceptable degree of stiffness at the steering wheel.

In the rear axle I replaced all the felt seals with modern lip seals, which was quite easy to do except for the inner halfshaft seals. The original felt halfshaft seal sits in a metal cup that is held in the housing by a wire clip and a retaining plate. The lip seals that were supplied to me were a good fit into the cup but the cup itself was a very loose fit in its housing. In the case of a thick felt seal this did not matter as the cup and seal would have been held in place by the wire clip and the plate. With a modern lip seal (being thinner than the felt seal) the clip and plate would not have trapped the cup and seal, the lip of the seal would have gripped onto the halfshaft and the seal and the cup would have rotated with the halfshaft. Luckily David Cochrane was able to supply me with lip seals to fit direct into the housings. The diameters of the housings are not machined to fine tolerances and David supplied seals of different outer diameter for each side.

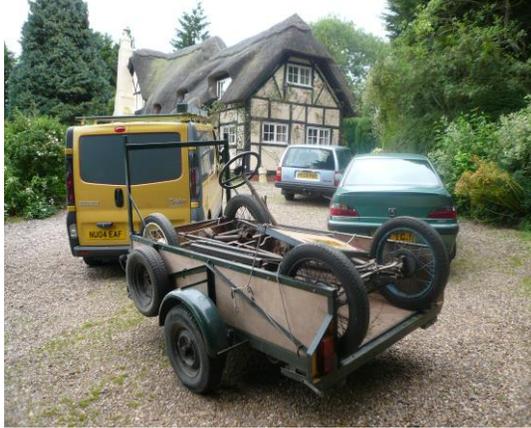
A Swallow Saga

Well, while Jon carries on with the body the chassis is brought home in an 8x4 trailer, handy eh!

Now we can start to get the basics sorted out by firstly having it sand blasted. After blasting and stripping it down we discovered, much to our delight, that it was in amazing condition and required no welding at all. The only thing we could see, was the front axle had been bent and would need replacing together with the worn king pins, bushes, and mountings as you would expect from something of this age. The rear axle appears to be sound but we will check in more detail in due course.

We sourced a new front axle that was straight and have sent it away to be reconditioned and have new king pins fitted,. While we wait, we will order the new bushes, spring shackles etc, and give the chassis a good coat of paint.
